**Flood Control Project Maintenance  
Levee Inspections**

## Maintenance Issue Types Only, Levee Inspection Report By Mile - Spring 2019

### American River Flood Control District

Waterway	Bank	Unit Miles	Inspection Start/End	Inspector
Unit No. 01 Arcade Creek	Left	2.08	05/14/2019 05/14/2019	Luz Dial

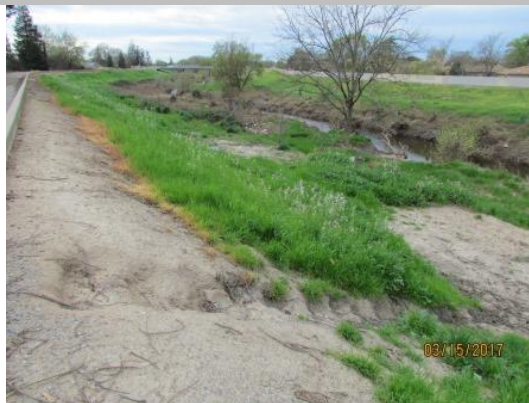
Photo 1 of 1 : SP\_2019\_NA0001\_51\_75\_20190307\_00049.jpg

LM Start	1.48	Rating **	M	Issue No.	75
LM End	1.48	Issue Type +	Ma	Location *	WS
Category	Earthen Levee			GPS Latitude/Longitude	
				Start	End
Item	Slope Stability			38.626912 °	38.626912 °
				-121.443229 °	-121.443229 °
DWR ID	DWR_NA0001_01_s_2017_75				
Comment Code					
S2 : Repair the levee slope damaged by foot traffic and prevent access where possible.					
Inspector Comment					
Stairs dug into waterside levee slope.

View of the stairs in the levee slope, looking downstream.

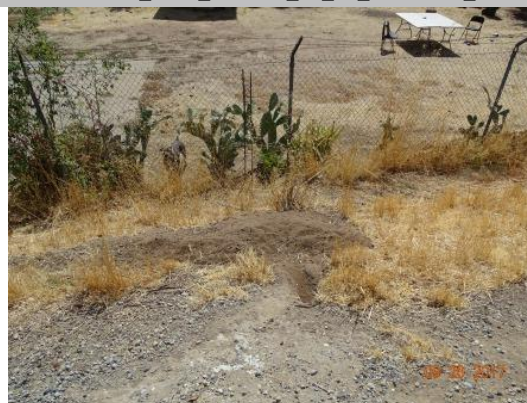
Photo 1 of 1 : SP\_2019\_NA0001\_51\_11\_20190307\_00010.jpg

View of the rodent activity on the levee slope.

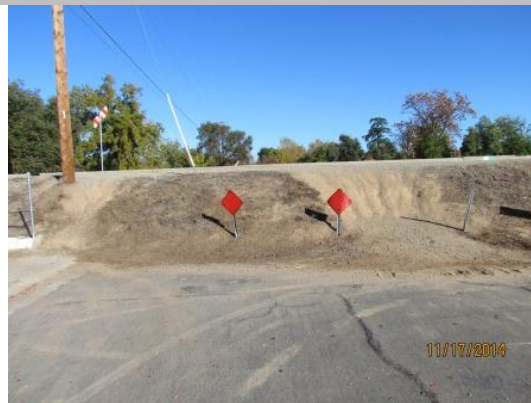
Photo 1 of 1 : SP\_2019\_NA0001\_51\_54\_20190307\_00035.jpg

LM Start	1.58	Rating **	A/W	Issue No.	54
LM End	1.58	Issue Type +	Ma	Location *	LS
Category	Earthen Levee			GPS Latitude/Longitude	
				Start	End
Item	Slope Stability			38.627251 °	38.627251 °
				-121.441460 °	-121.441460 °
DWR ID	DWR_NA0001_01_s_2012_54				
Comment Code					
S2 : Repair the levee slope damaged by foot traffic and prevent access where possible.					
Inspector Comment

Slope stability due to foot traffic needs to be monitored.

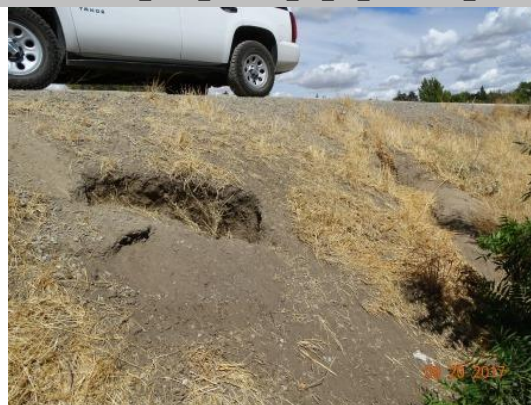
Photo 1 of 1 : SP\_2019\_NA0001\_51\_65\_20190307\_00042.jpg

View of the animal activity on the levee slope.

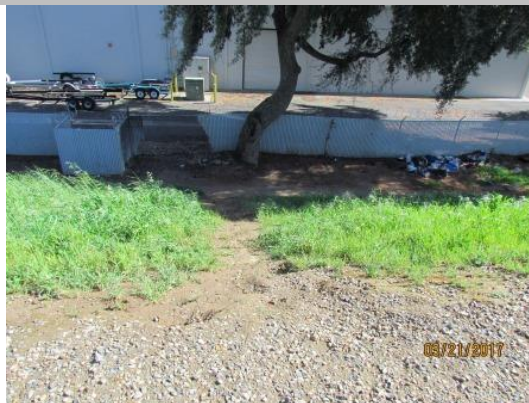
Photo 1 of 1 : SP\_2019\_NA0001\_52\_19\_20190307\_00007.jpg

View of the stairs dug into the landside levee slope. Spring 2017

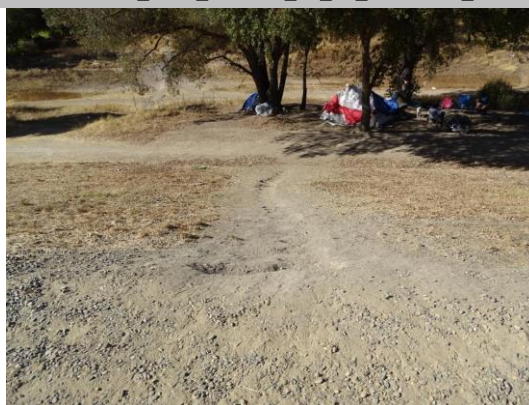
Photo 1 of 1 : SP\_2019\_NA0001\_52\_39\_20190307\_00021.jpg

LM Start	0.17	Rating **	A/W	Issue No.	39
LM End	0.17	Issue Type +	Ma	Location *	WS
Category	Earthen Levee			GPS Latitude/Longitude	
				Start	End
Item	Slope Stability			38.604455 °	38.604455 °
				-121.470417 °	-121.470417 °
DWR ID	DWR_NA0001_02_f_2018_39				
Comment Code					
S2 : Repair the levee slope damaged by foot traffic and prevent access where possible.					
Inspector Comment					
Monitor footpath on waterside slope.

View of stair steps dug into levee slope. Fall 2018

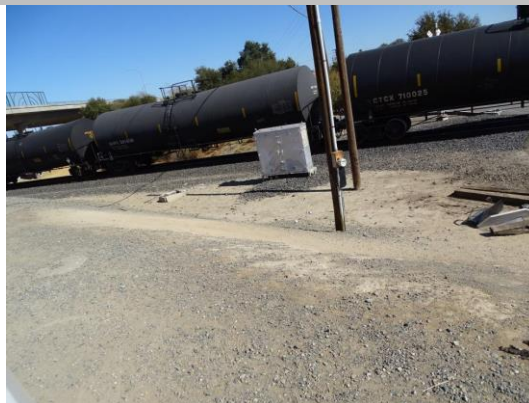
Photo 1 of 1 : SP\_2019\_NA0001\_52\_23\_20190307\_00010.jpg

LM Start	0.33	Rating **	A/W	Issue No.	23
LM End	0.33	Issue Type +	Ma	Location *	LS
Category	Earthen Levee			GPS Latitude/Longitude	
				Start	End
Item	Slope Stability			38.605827 °	38.605827 °
				-121.468071 °	-121.468071 °
DWR ID	DWR_NA0001_02_f_2018_23				
Comment Code					
S2 : Repair the levee slope damaged by foot traffic and prevent access where possible.					
Inspector Comment					
Monitor footpath on levee slope.

View of footpath on levee slope. Fall 2018

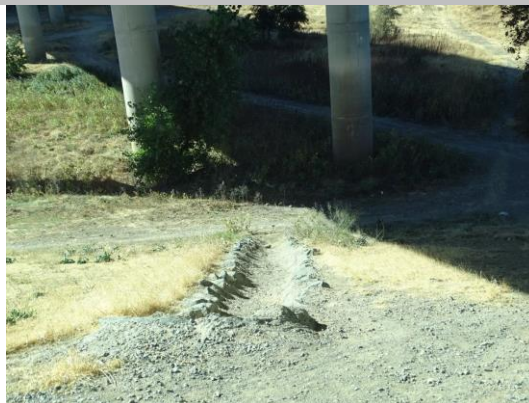
Photo 1 of 1 : SP\_2019\_NA0001\_52\_42\_20190307\_00024.jpg

LM Start	0.36	Rating **	A/W	Issue No.	42
LM End	0.36	Issue Type +	Ma	Location *	WS
Category	Earthen Levee			GPS Latitude/Longitude	
				Start	End
Item	Slope Stability			38.606229 °	38.606229 °
				-121.467867 °	-121.467867 °
DWR ID	DWR_NA0001_02_f_2018_42				
Comment Code					
S2 : Repair the levee slope damaged by foot traffic and prevent access where possible.					
Inspector Comment					
Repair slope damage from a footpath dug into the slope. Part of overpass drainage.

View of footpath dug into levee slope and lined with rocks. Fall 2018

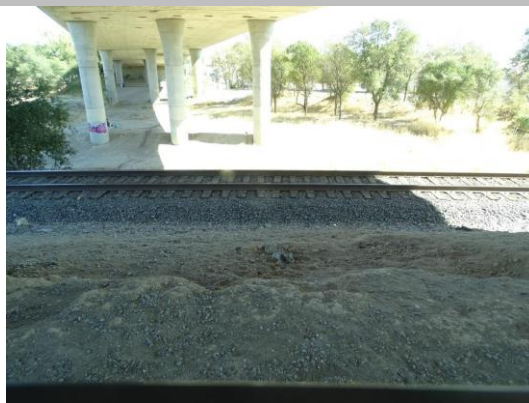
Photo 1 of 1 : SP\_2019\_NA0001\_52\_21\_20190307\_00008.jpg

LM Start	0.37	Rating **	M	Issue No.	21
LM End	0.37	Issue Type +	Ma	Location *	LS
Category	Earthen Levee			GPS Latitude/Longitude	
				Start	End
Item	Slope Stability			38.606430 °	38.606430 °
				-121.467782 °	-121.467782 °
DWR ID	DWR_NA0001_02_f_2018_21				
Comment Code					
S1 : Repair slope instability.					
Inspector Comment					
Repair slope damage.

View of slope damage on levee slope. Fall 2018

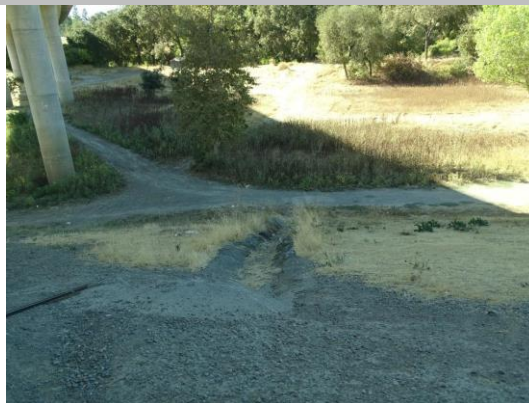
Photo 1 of 1 : SP\_2019\_NA0001\_52\_43\_20190307\_00025.jpg

LM Start	0.37	Rating **	A/W	Issue No.	43
LM End	0.37	Issue Type +	Ma	Location *	WS
Category	Earthen Levee			GPS Latitude/Longitude	
				Start	End
Item	Slope Stability			38.606435°	38.606435°
				-121.467772°	-121.467772°
DWR ID	DWR_NA0001_02_f_2018_43				
Comment Code					
S2 : Repair the levee slope damaged by foot traffic and prevent access where possible.					
Inspector Comment					
Repair slope damage from footpath dug into slope. Part of overpass drainage.

View of footpath dug into levee slope and lined with rocks. Fall 2018

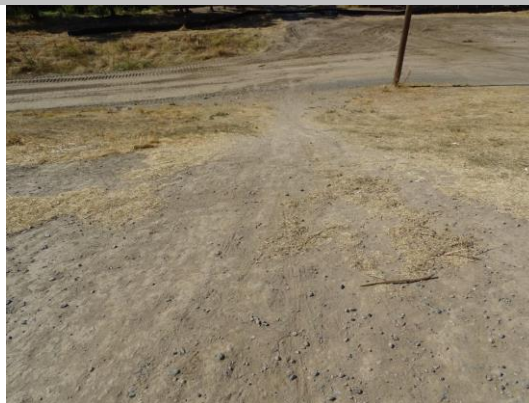
Photo 1 of 1 : SP\_2019\_NA0001\_52\_35\_20190307\_00018.jpg

LM Start	0.73	Rating **	A/W	Issue No.	35
LM End	0.73	Issue Type +	Ma	Location *	WS
Category	Earthen Levee			GPS Latitude/Longitude	
				Start	End
Item	Slope Stability			38.611458 °	38.611458 °
				-121.466495 °	-121.466495 °
DWR ID	DWR_NA0001_02_f_2018_35				
Comment Code					
S1 : Repair slope instability.					
Inspector Comment					
Monitor footpath damage.

View of footpath on waterside slope. Fall 2018

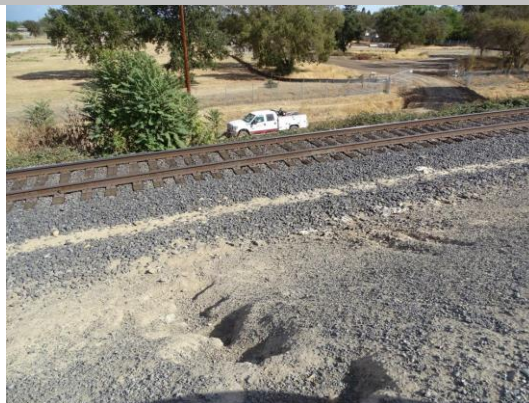
Photo 1 of 1 : SP\_2019\_NA0001\_52\_41\_20190307\_00023.jpg

LM Start	0.92	Rating **	M	Issue No.	41
LM End	0.92	Issue Type +	Ma	Location *	LS
Category	Earthen Levee			GPS Latitude/Longitude	
				Start	End
Item	Slope Stability			38.614240 °	38.614240 °
				-121.466645 °	-121.466645 °
DWR ID	DWR_NA0001_02_s_2019_41				
Comment Code					
S2 : Repair the levee slope damaged by foot traffic and prevent access where possible.					
Inspector Comment					
Repair slope damage from footpath dug into levee.

View of steps dug into levee slope. Fall 2018

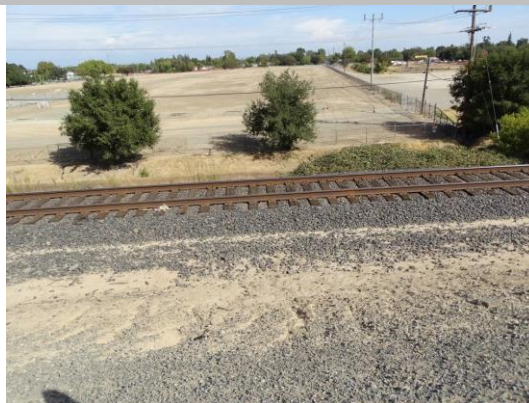
Photo 1 of 1 : SP\_2019\_NA0001\_52\_40\_20190307\_00022.jpg

View of erosion rills on slope. Fall 2018

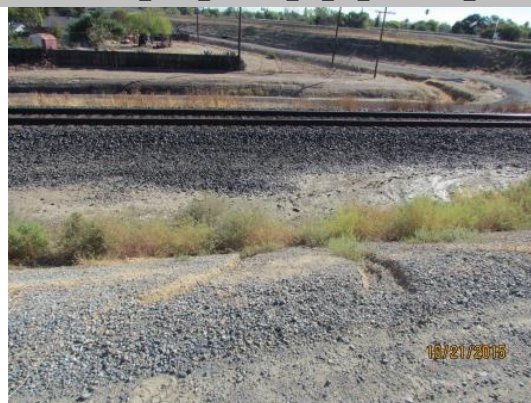
Photo 1 of 1 : SP\_2019\_NA0001\_52\_26\_20190307\_00013.jpg

LM Start	1.40	Rating **	A/W	Issue No.	26
LM End	1.40	Issue Type +	Ma	Location *	LS
Category	Earthen Levee			GPS Latitude/Longitude	
				Start	End
Item	Slope Stability			38.621054 °	38.621054 °
				-121.468008 °	-121.468008 °
DWR ID	DWR_NA0001_02_f_2015_26				
Comment Code					
S3 : Repair the levee slope damaged by vehicle traffic and prevent access where possible.					
Inspector Comment					
Monitor slope damage from vehicle traffic.

View of the damaged landside levee slope. Fall 2015

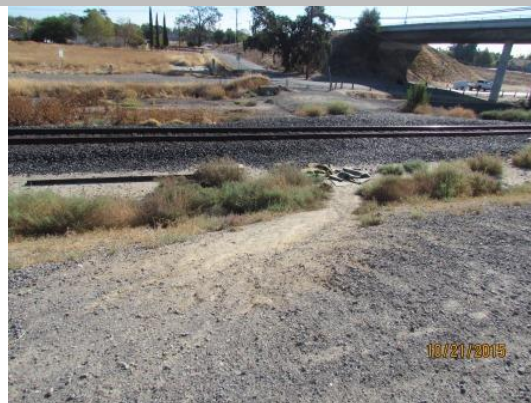
Photo 1 of 1 : SP\_2019\_NA0001\_52\_25\_20190307\_00012.jpg

LM Start	2.05	Rating **	M	Issue No.	25
LM End	2.05	Issue Type +	Ma	Location *	LS
Category	Earthen Levee			GPS Latitude/Longitude	
				Start	End
Item	Slope Stability			38.630425 °	38.630425 °
				-121.469807 °	-121.469807 °
DWR ID	DWR_NA0001_02_f_2015_25				
Comment Code					
S2 : Repair the levee slope damaged by foot traffic and prevent access where possible.					
Inspector Comment

View of the landside levee slope damaged by foot traffic.

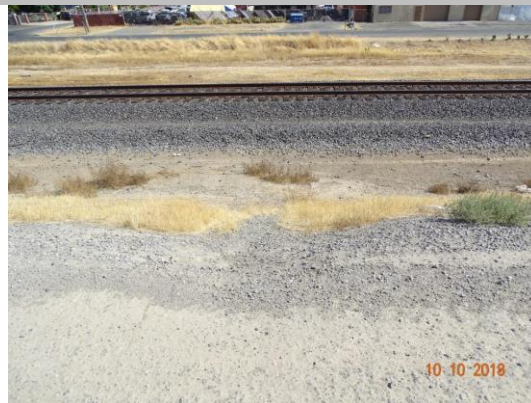
Photo 1 of 1 : SP\_2019\_NA0001\_52\_31\_20190307\_00017.jpg

LM Start	2.22	Rating **	A/W	Issue No.	31
LM End	2.22	Issue Type +	Ma	Location *	LS
Category	Earthen Levee			GPS Latitude/Longitude	
				Start	End
Item	Slope Stability			38.632841 °	38.632841 °
				-121.470258 °	-121.470258 °
DWR ID	DWR_NA0001_02_f_2018_31				
Comment Code					
S1 : Repair slope instability.					
Inspector Comment					
Monitor slope damage.

View of slope damage possibly from foot traffic. Fall 2018

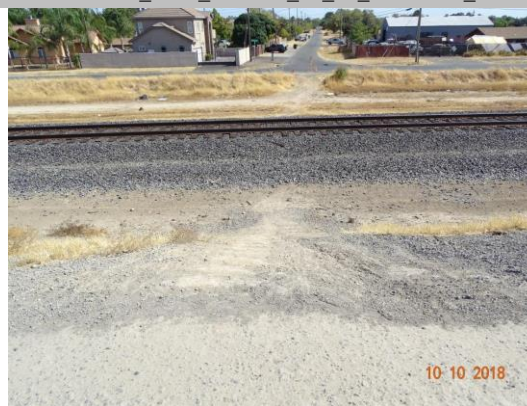
Photo 1 of 1 : SP\_2019\_NA0001\_52\_30\_20190307\_00016.jpg

LM Start	2.25	Rating **	M	Issue No.	30
LM End	2.25	Issue Type +	Ma	Location *	LS
Category	Earthen Levee			GPS Latitude/Longitude	
				Start	End
Item	Slope Stability			38.633308 °	38.633308 °
				-121.470349 °	-121.470349 °
DWR ID	DWR_NA0001_02_f_2018_30				
Comment Code					
S2 : Repair the levee slope damaged by foot traffic and prevent access where possible.					
Inspector Comment					
Erosion is worsening around steps dug into levee slope.

View of stairs steps dug into levee slope. Fall 2018

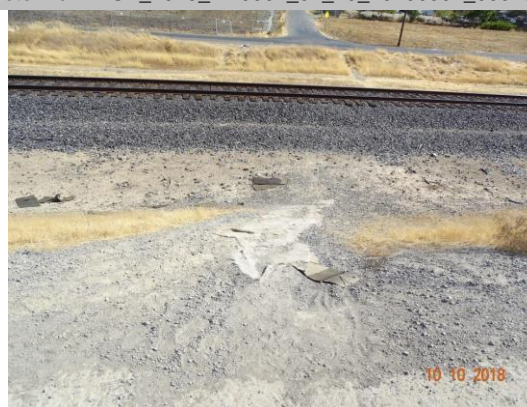
Photo 1 of 1 : SP\_2019\_NA0001\_52\_29\_20190307\_00015.jpg

LM Start	2.36	Rating **	M	Issue No.	29
LM End	2.36	Issue Type +	Ma	Location *	LS
Category	Earthen Levee			GPS Latitude/Longitude	
				Start	End
Item	Slope Stability			38.634885 °	38.634885 °
				-121.470643 °	-121.470643 °
DWR ID	DWR_NA0001_02_f_2018_29				
Comment Code					
S2 : Repair the levee slope damaged by foot traffic and prevent access where possible.					
Inspector Comment					
Repair footpath on levee slope.

View of footpath on levee slope. Fall 2018

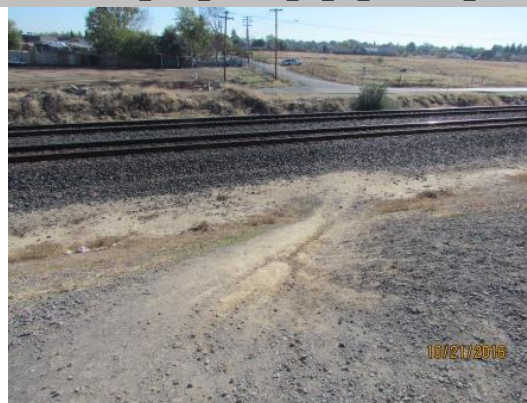
Photo 1 of 1 : SP\_2019\_NA0001\_52\_27\_20190307\_00014.jpg

LM Start	2.59	Rating **	M	Issue No.	27
LM End	2.59	Issue Type +	Ma	Location *	LS
Category	Earthen Levee			GPS Latitude/Longitude	
				Start	End
Item	Slope Stability			38.638109 °	38.638109 °
				-121.471254 °	-121.471254 °
DWR ID	DWR_NA0001_02_f_2016_27				
Comment Code					
S2 : Repair the levee slope damaged by foot traffic and prevent access where possible.					
Inspector Comment

View of the foot path on the landside levee slope. Fall 2016

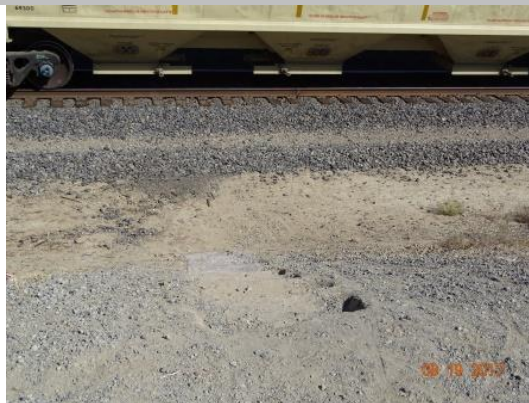
Photo 1 of 1 : SP\_2019\_NA0001\_52\_1\_20190307\_00001.jpg

View of the unpermitted steps in the levee.

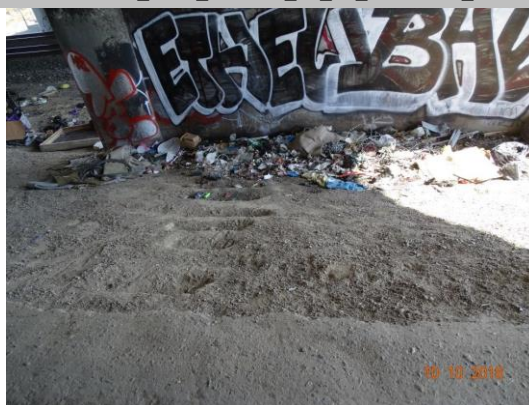
Photo 1 of 1 : SP\_2019\_NA0001\_52\_22\_20190307\_00009.jpg

LM Start	2.81	Rating **	M	Issue No.	22
LM End	2.81	Issue Type +	Ma	Location *	LS
Category	Earthen Levee			GPS Latitude/Longitude	
				Start	End
Item	Slope Stability			38.641309 °	38.641309 °
				-121.471798 °	-121.471798 °
DWR ID	DWR_NA0001_02_f_2018_22				
Comment Code					
S2 : Repair the levee slope damaged by foot traffic and prevent access where possible.					
Inspector Comment					
Steps cut into levee slope.

View of foot path steps cut into levee. Fall 2018

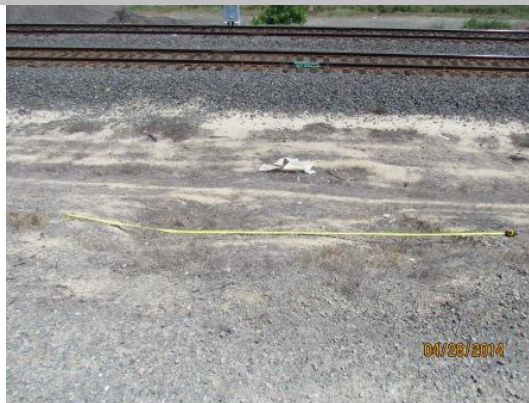
Photo 1 of 1 : SP\_2019\_NA0001\_52\_6\_20190307\_00002.jpg

View of landside slope instability. Spring 2014

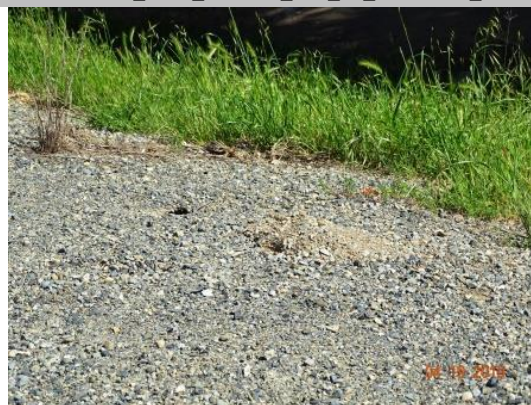
Photo 1 of 1 : SP\_2019\_NA0001\_490\_13\_20190422\_00031.jpg

View of animal holes on levee slope. Spring 2019

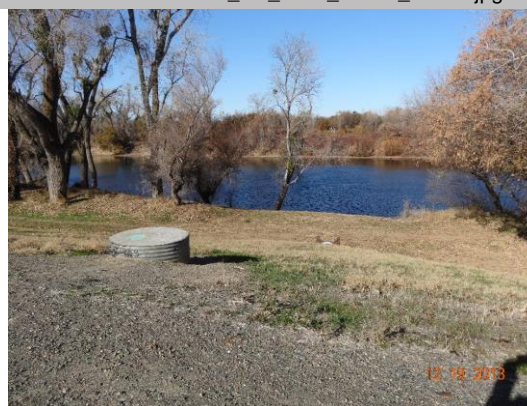
Photo 3 of 3 : UCIP\_SP\_2019\_31249\_57210.jpg

View of waterward side--standpipe located on waterward slope. Standpipe filled with concrete.

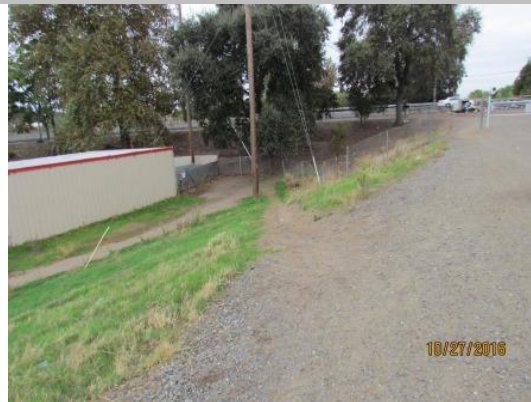
Photo 1 of 1 : SP\_2019\_NA0001\_55\_244\_20190307\_00194.jpg

View of the footpath on the landside levee slope. Fall 2016

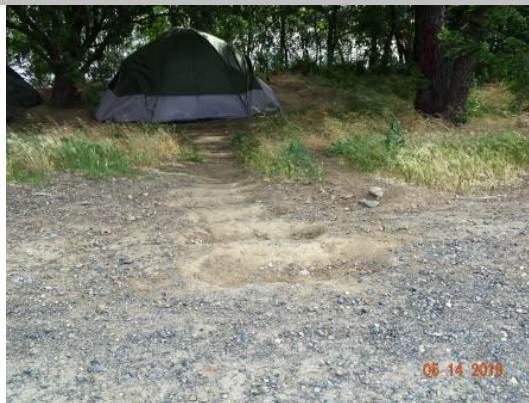
Photo 1 of 1 : SP\_2019\_NA0001\_55\_197\_20190515\_00274.jpg

View looking northeast at steps that the homeless dug into the levee slope. Spring 2019

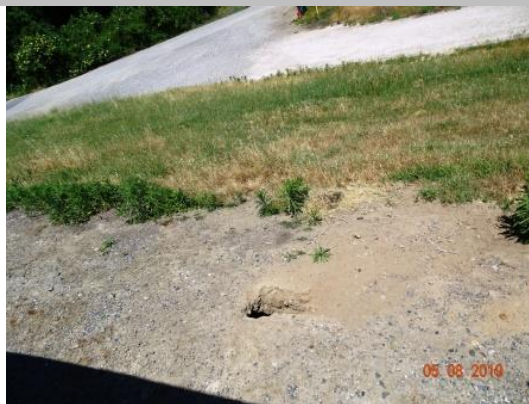
Photo 1 of 1 : SP\_2019\_NA0001\_55\_186\_20190513\_00265.jpg

View looking downstream at animal hole on waterside slope. Spring 2019

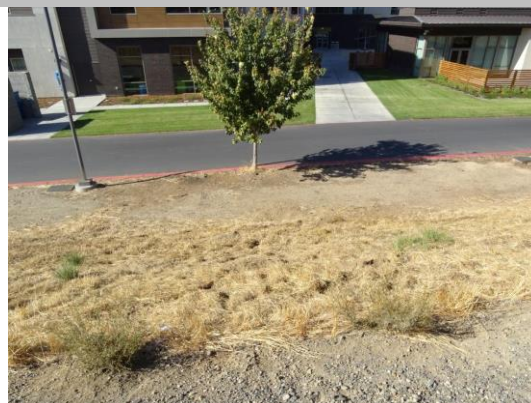
Photo 1 of 1 : SP\_2019\_NA0001\_55\_271\_20190307\_00208.jpg

View of animal holes. Fall 2018

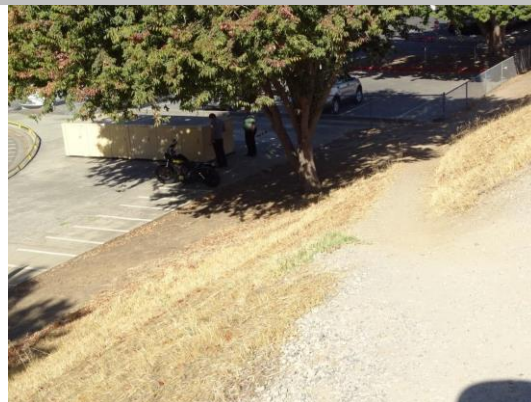
Photo 1 of 1 : SP\_2019\_NA0001\_55\_270\_20190307\_00207.jpg

View of footpath on slope. Fall 2018

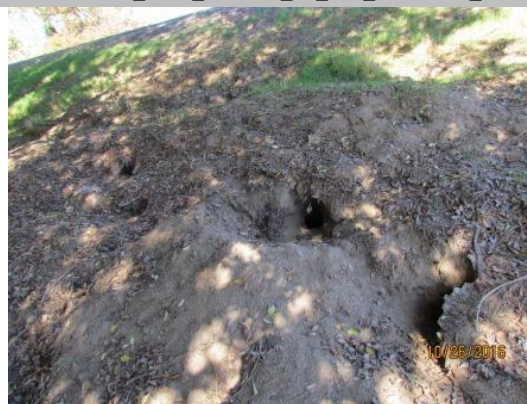
Photo 1 of 2 : SP\_2019\_NA0001\_55\_240\_20190307\_00192.jpg

View of a rodent burrows at the landside levee toe.

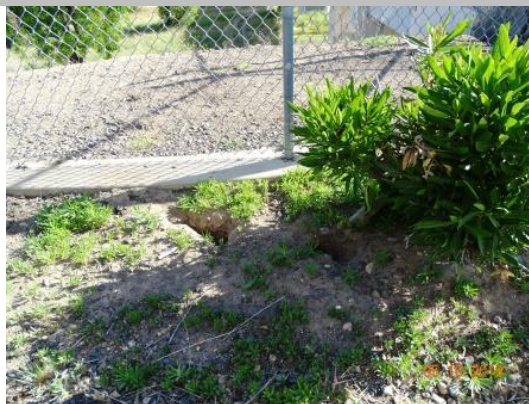
Photo 1 of 2 : SP\_2019\_NA0001\_55\_286\_20190515\_00272.jpg

View looking north at animal holes on the levee crown within the City facility. Spring 2019

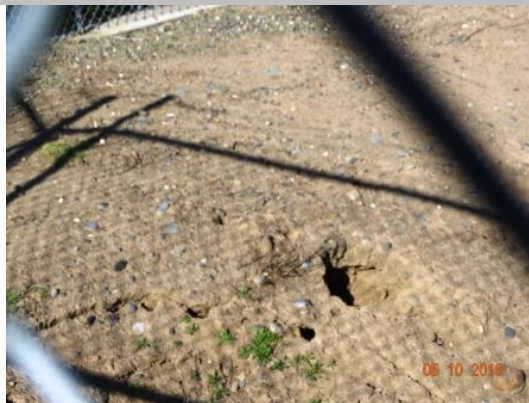
Photo 2 of 2 : SP\_2019\_NA0001\_55\_286\_20190515\_00273.jpg

View looking downstream at animal holes on the upper slope outside the City facility. Spring 2019

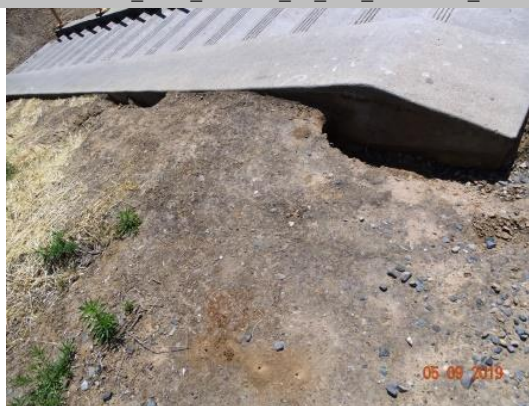
Photo 1 of 1 : SP\_2019\_NA0001\_55\_278\_20190515\_00270.jpg

View looking downstream at erosion adjacent to concrete stairway.  
Spring 2019

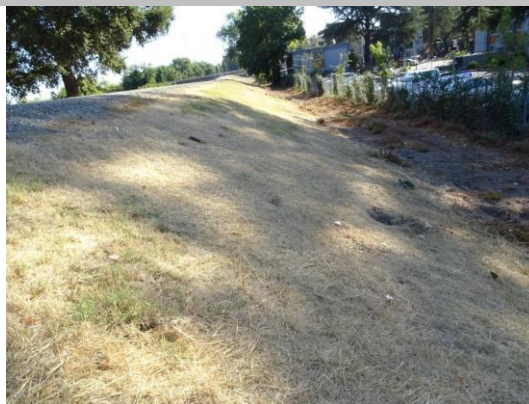
Photo 1 of 1 : SP\_2019\_NA0001\_55\_266\_20190307\_00206.jpg

View of animal burrows. Fall 2018

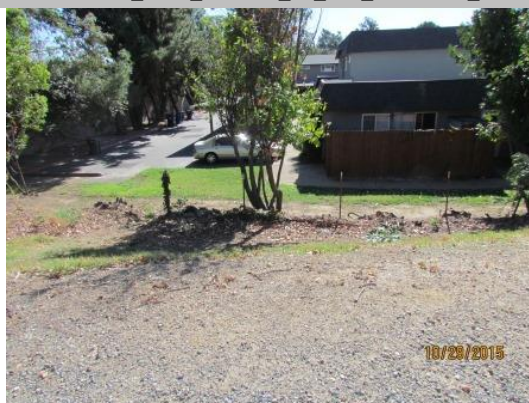
Photo 1 of 1 : SP\_2019\_NA0001\_55\_230\_20190307\_00188.jpg

View of the multiple tree stumps at the landside levee toe.

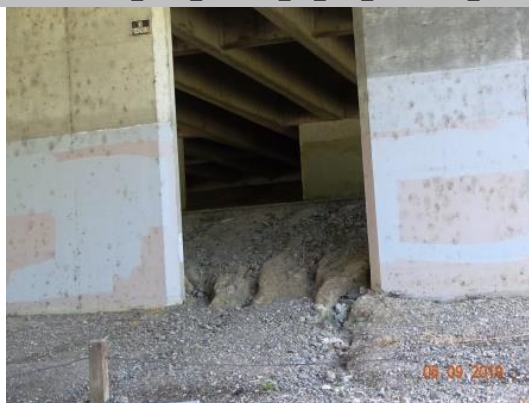
Photo 1 of 1 : SP\_2019\_NA0001\_55\_242\_20190515\_00266.jpg

View looking south at erosion rills underneath bridge. Spring 2019

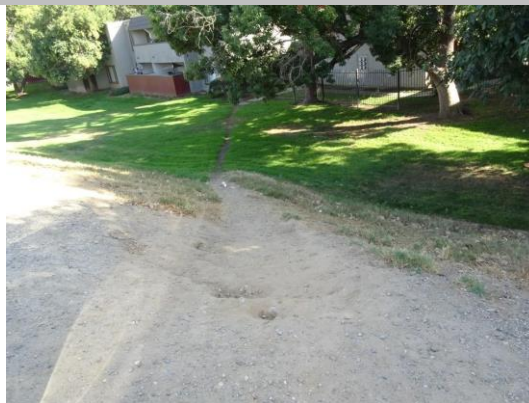
Photo 1 of 1 : SP\_2019\_NA0001\_55\_252\_20190307\_00198.jpg

View of footpath on levee toe. Fall 2018

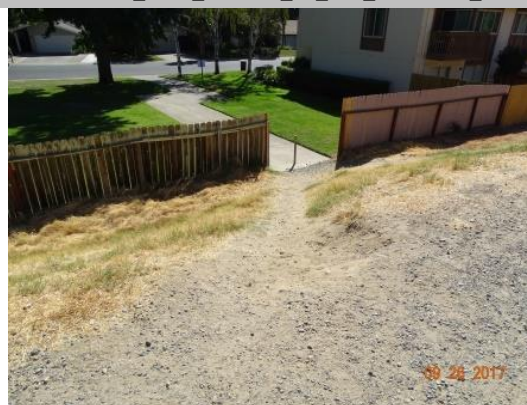
Photo 1 of 1 : SP\_2019\_NA0001\_55\_228\_20190307\_00186.jpg

View of the footpath on the levee slope.

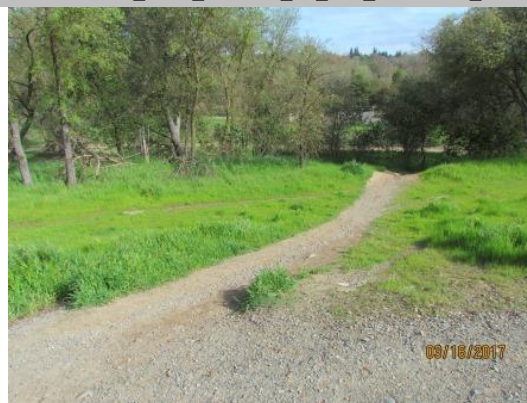
Photo 1 of 1 : SP\_2019\_NA0001\_55\_219\_20190307\_00181.jpg

View of the footpath on the levee slope.

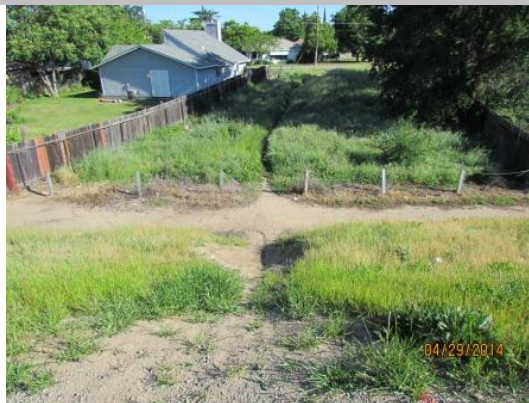
Photo 1 of 1 : SP\_2019\_NA0001\_58\_34\_20190307\_00029.jpg

View of the landside levee slope damaged by foot traffic.

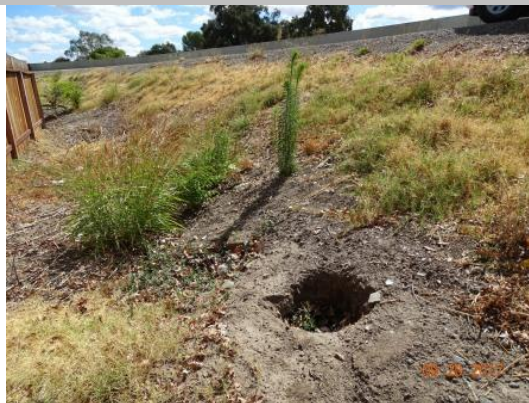
Photo 1 of 1 : SP\_2019\_NA0001\_58\_18\_20190307\_00017.jpg

View of the rodent hole that needs to be backfilled.

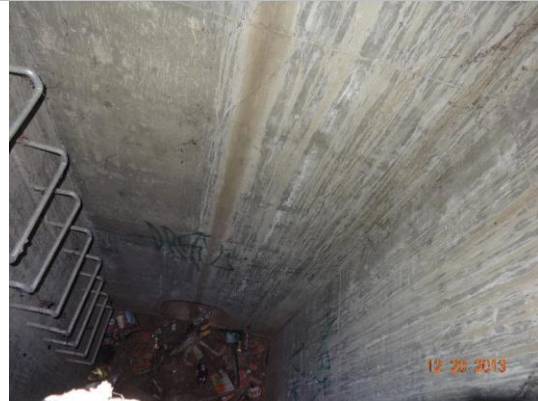
Photo 3 of 3 : UCIP\_SP\_2019\_29326\_54320.jpg

Inside view of concrete riser located on waterward shoulder--debris found at the bottom of riser.

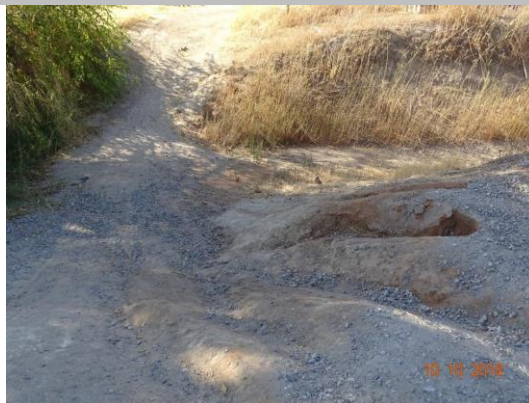
Photo 1 of 1 : SP\_2019\_NA0001\_59\_14\_20190307\_00010.jpg

View of slope damage near gate on an oversized section of levee. Fall 2018

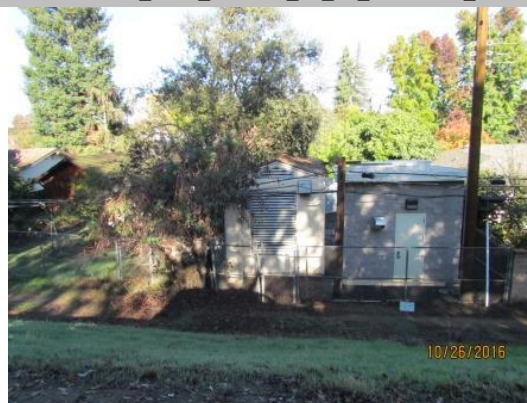
Photo 1 of 1 : SP\_2019\_NA0001\_60\_14\_20190307\_00005.jpg

View of tree trunk at fence line.

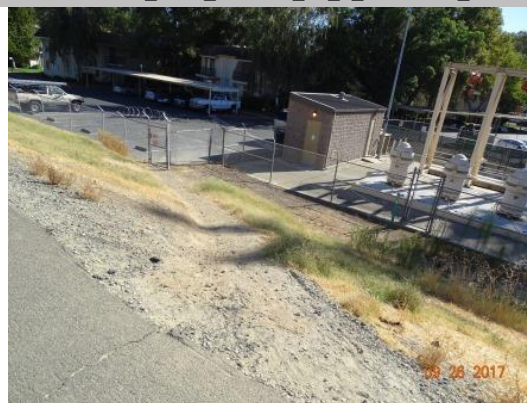
Photo 1 of 1 : SP\_2019\_NA0001\_60\_9\_20190307\_00004.jpg

View of the footpath on the levee slope.

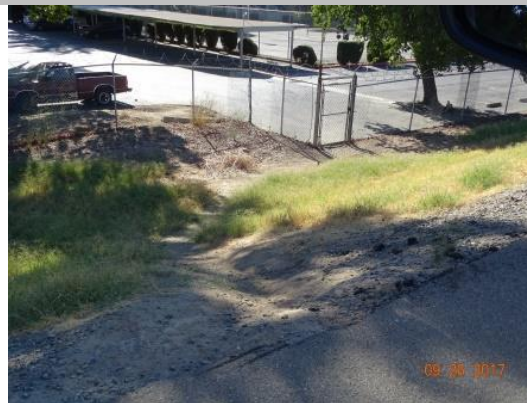
Photo 1 of 1 : SP\_2019\_NA0001\_60\_8\_20190307\_00003.jpg

View of the footpath on the levee slope.

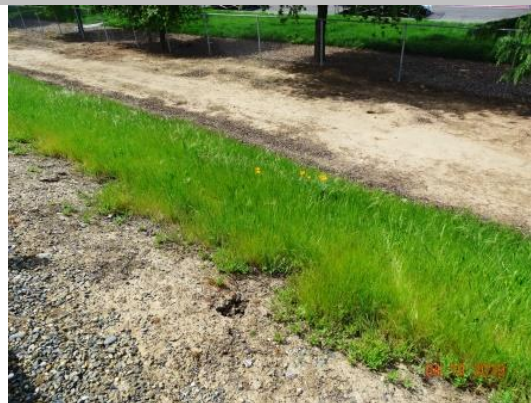
Photo 2 of 2 : SP\_2019\_NA0001\_61\_36\_20190422\_00050.jpg

View of animal holes on levee slope and toe road. Spring 2019

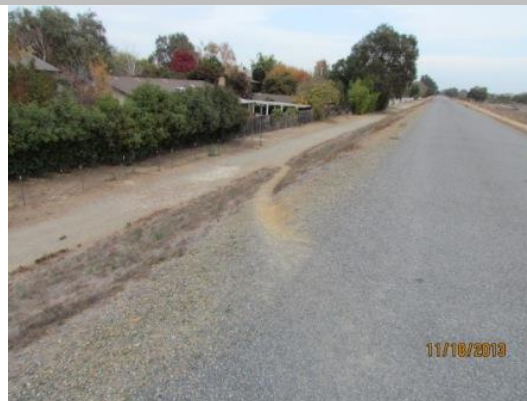
Photo 1 of 1 : SP\_2019\_NA0001\_61\_7\_20190307\_00002.jpg

View of the pathway on the landside levee slope.

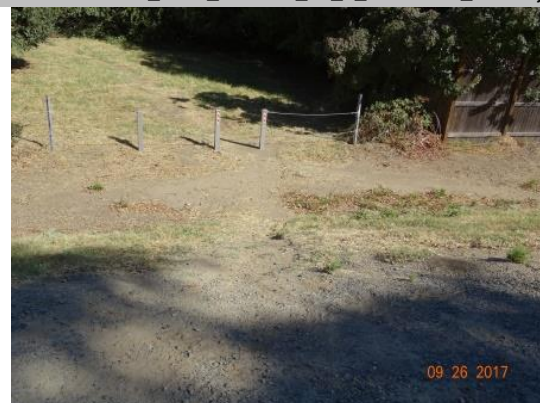
Photo 1 of 1 : SP\_2019\_NA0001\_61\_2\_20190307\_00001.jpg

View of the footpath on the levee slope. Fall 2017

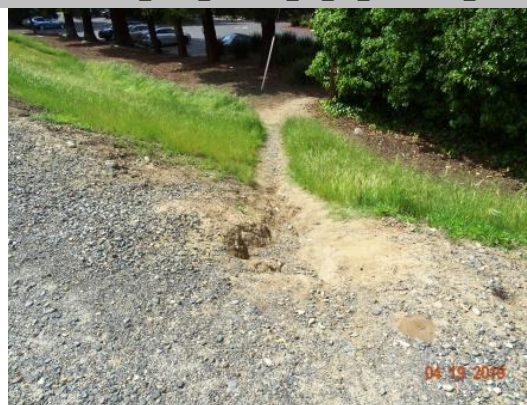
Photo 1 of 1 : SP\_2019\_NA0001\_61\_19\_20190422\_00051.jpg

View of footpath on landside slope. Spring 2019

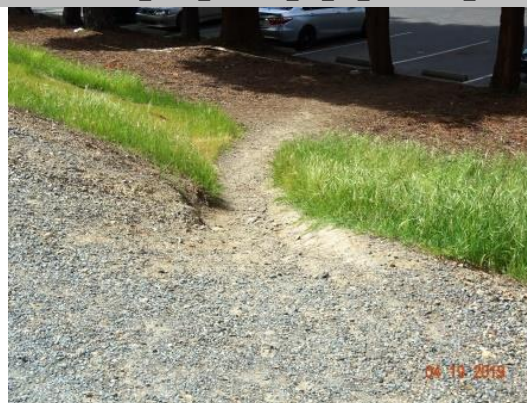
Photo 1 of 2 : SP\_2019\_NA0001\_61\_21\_20190422\_00052.jpg

View of footpath on landside slope. Spring 2019

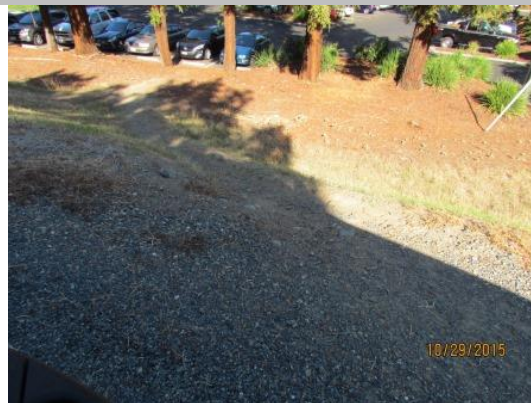
Photo 2 of 2 : SP\_2019\_NA0001\_61\_21\_20190307\_00004.jpg

View of the footpath on the landside levee slope.

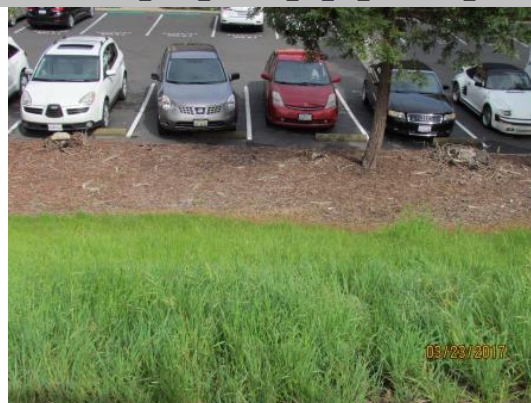
Photo 1 of 1 : SP\_2019\_NA0001\_61\_29\_20190307\_00009.jpg

View of the tree stumps within the levee easement.

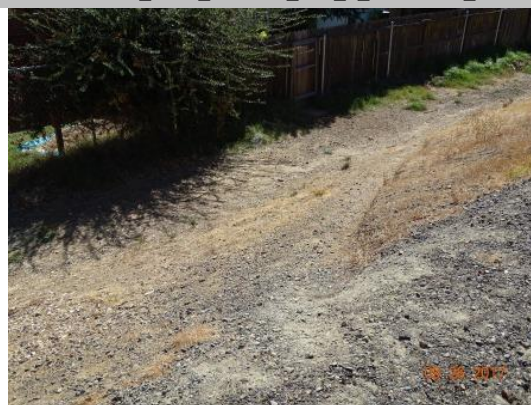
Photo 1 of 1 : SP\_2019\_NA0001\_438\_8\_20190307\_00004.jpg

View of the footpath on the levee slope.

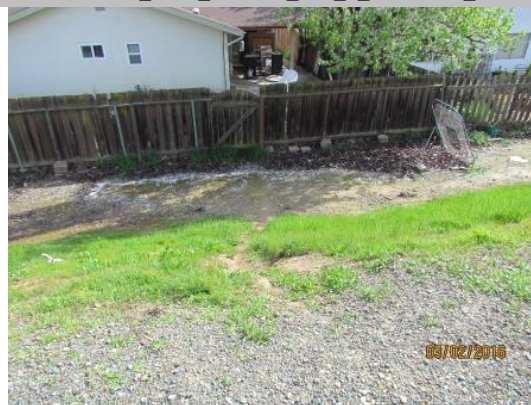
Photo 1 of 1 : SP\_2019\_NA0001\_438\_4\_20190307\_00003.jpg

View of the footpath on the landside levee slope.

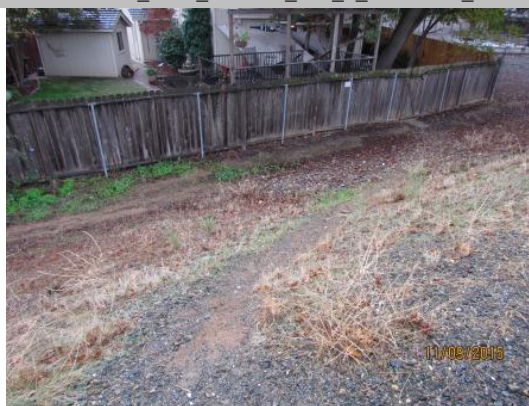
Photo 1 of 1 : SP\_2019\_NA0001\_438\_3\_20190307\_00002.jpg

View of the footpath on the landside levee slope.
